HISTORIC STRUCTURE REPORT

ST. PHILOMENA CATHOLIC CHURCH

KALAUPAPA NATIONAL HISTORICAL PARK
Molokai, Hawaii

January 1985

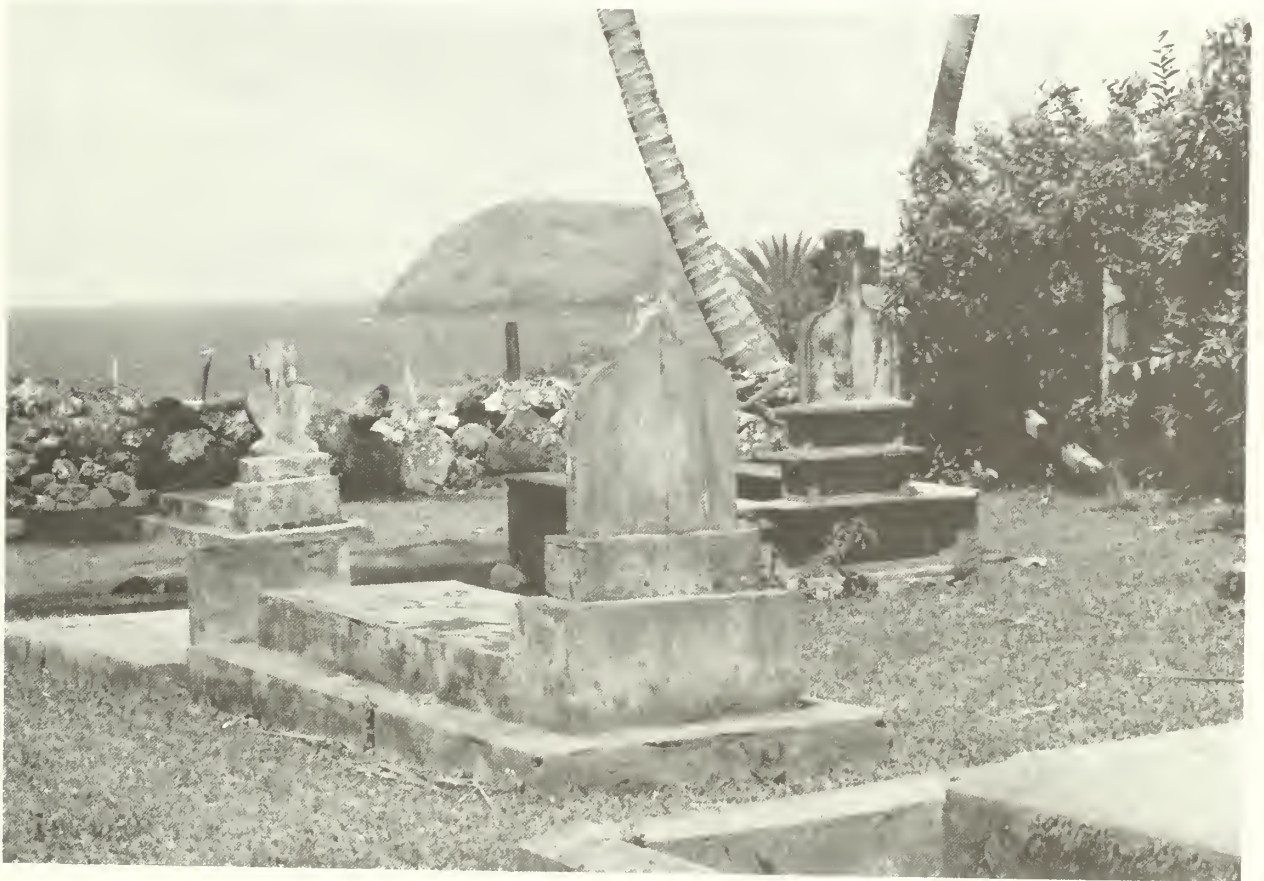
Illustration A106.

View toward sea of northeast portion of site. 6/84. R.L.C.

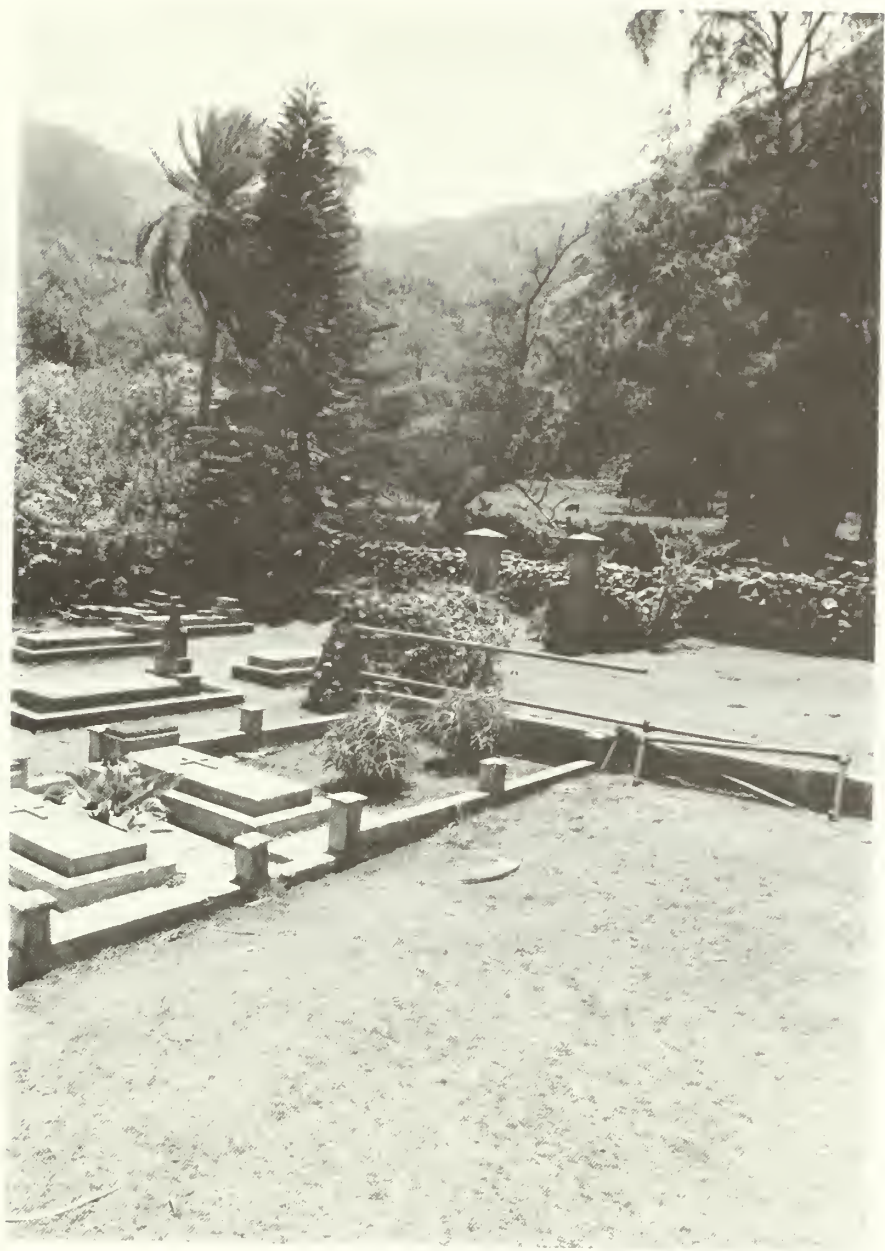
Illustration A107.

View of southeast corner of site. 8/84. P.C.C.

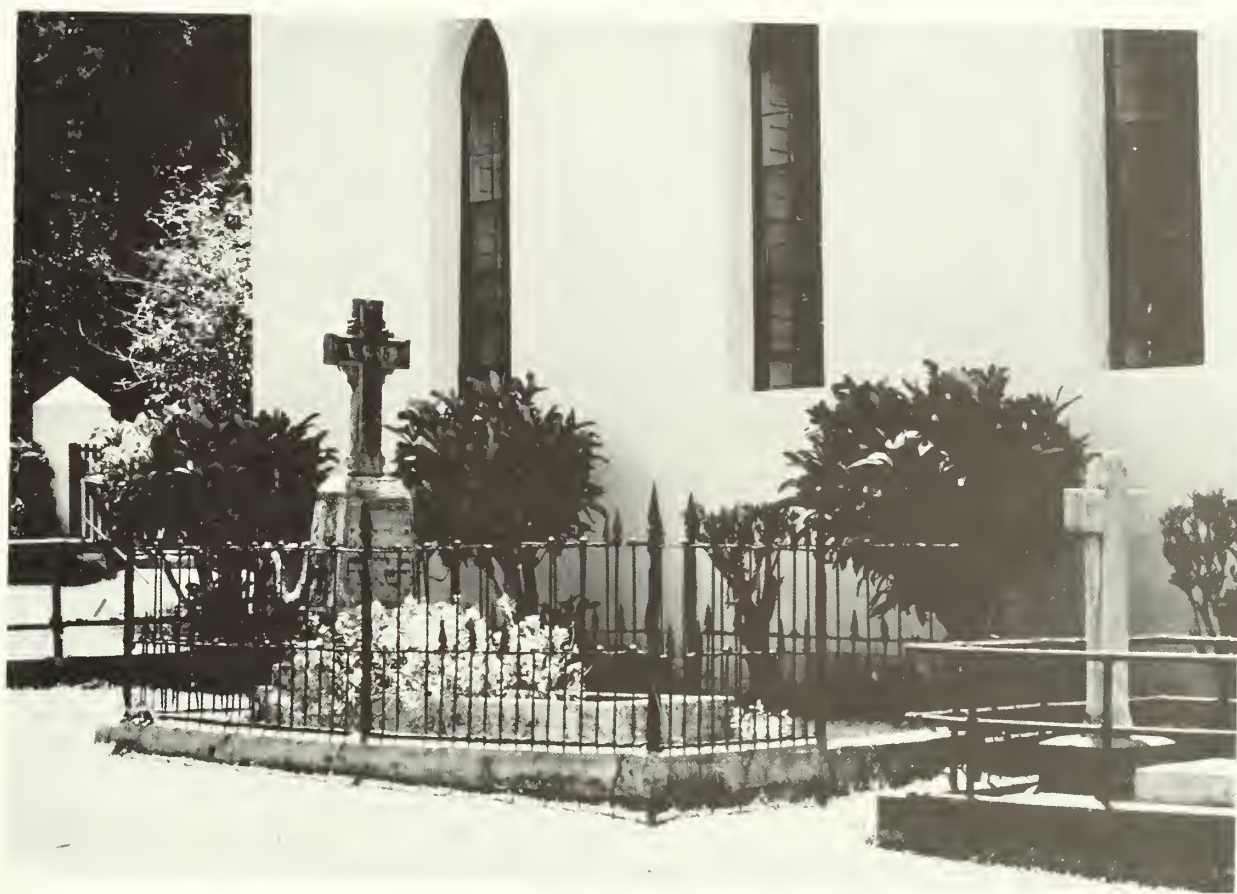
Illustration A108.

Fr. Damien's grave. 6/84. R.L.C.

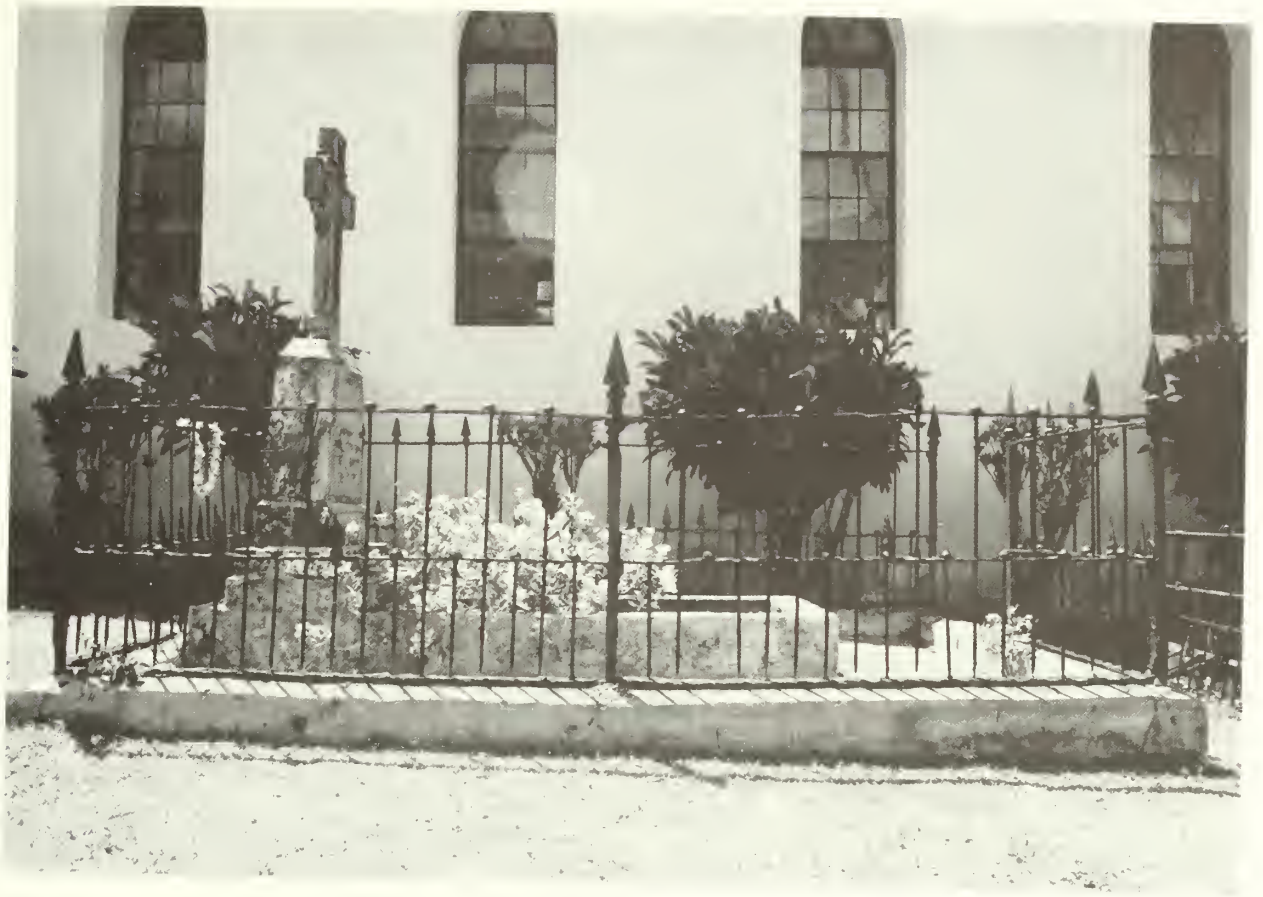
Illustration A109.

Fr. Damien's grave, from 'east'. 6/84. R.L.C.

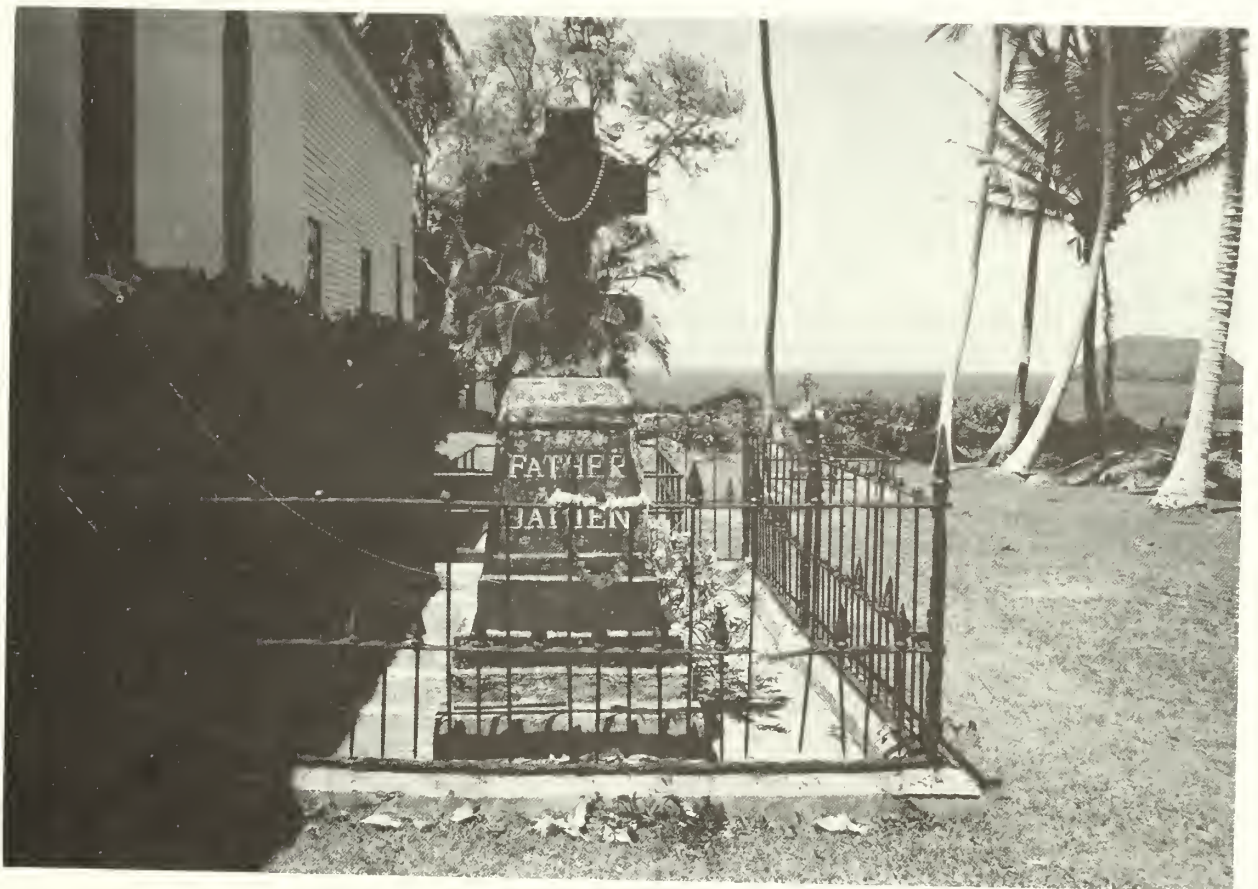
Illustration A110.

Fr. Damien's grave, from 'south'. 6/84. R.L.C.

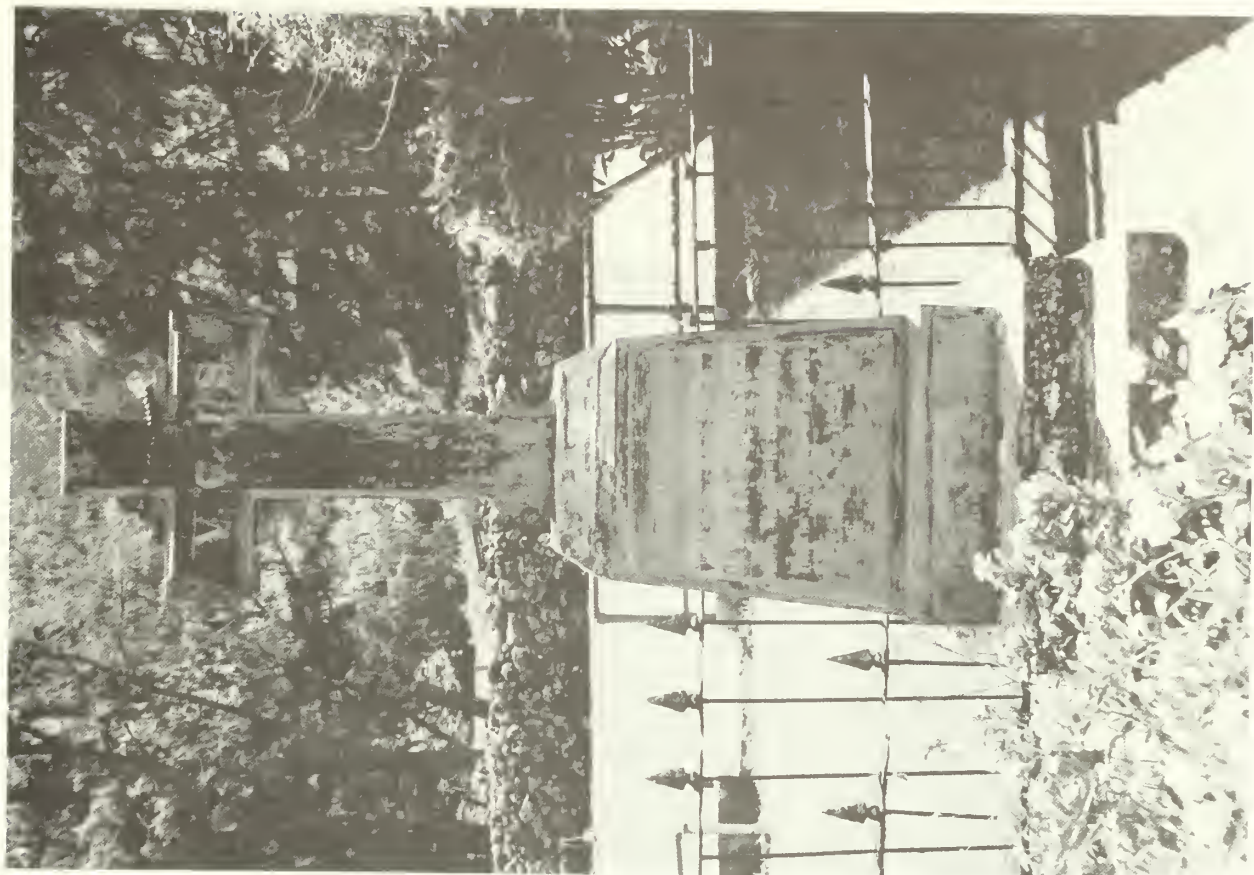
Illustration A111.

Fr. Damien's grave. Note deterioration of decorative railing and missing elements. Part of gate still exists. 8/84. P.C.C.

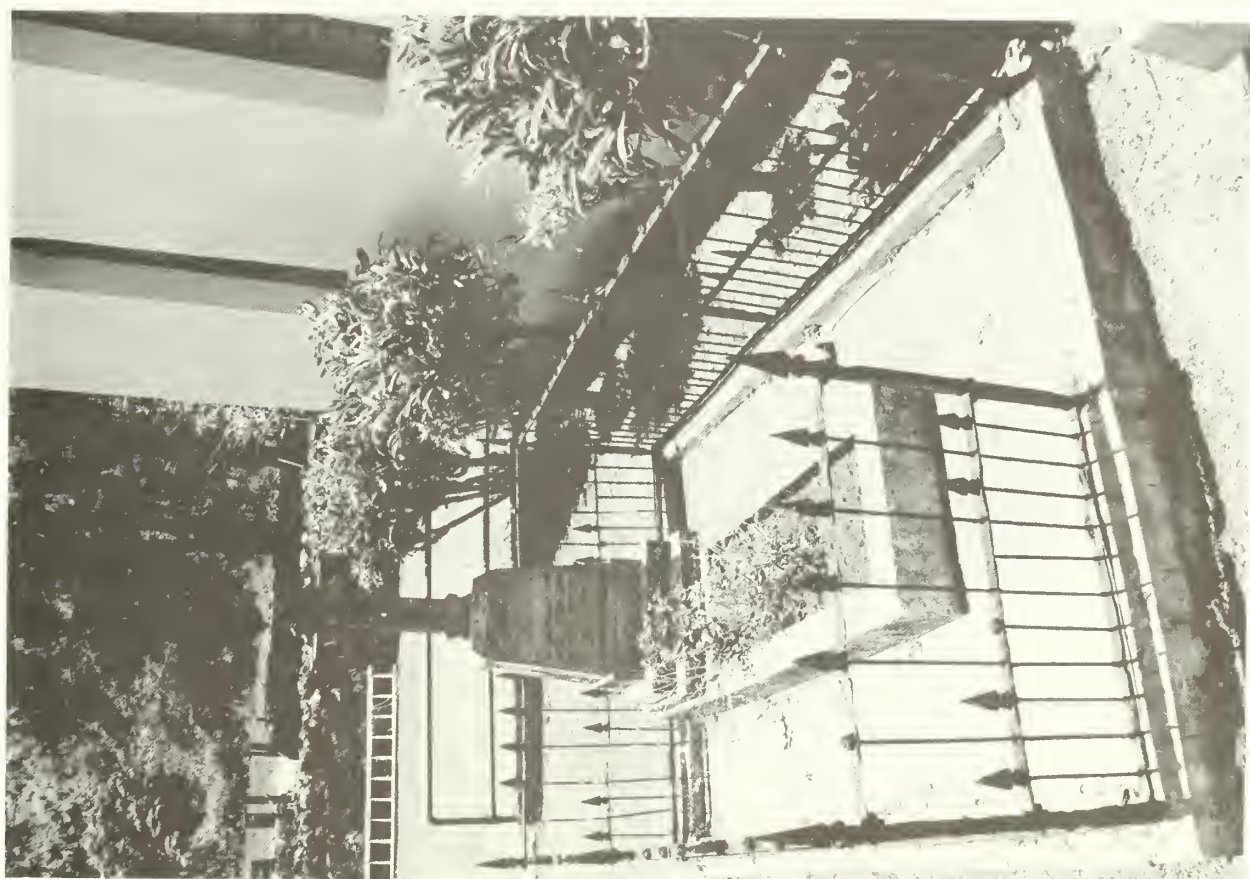
Illustration A112.

Fr. Damien's grave. Although some stone was used, concrete was used extensively for the grave markers at St. Philomena. 6/84. R.L.C.

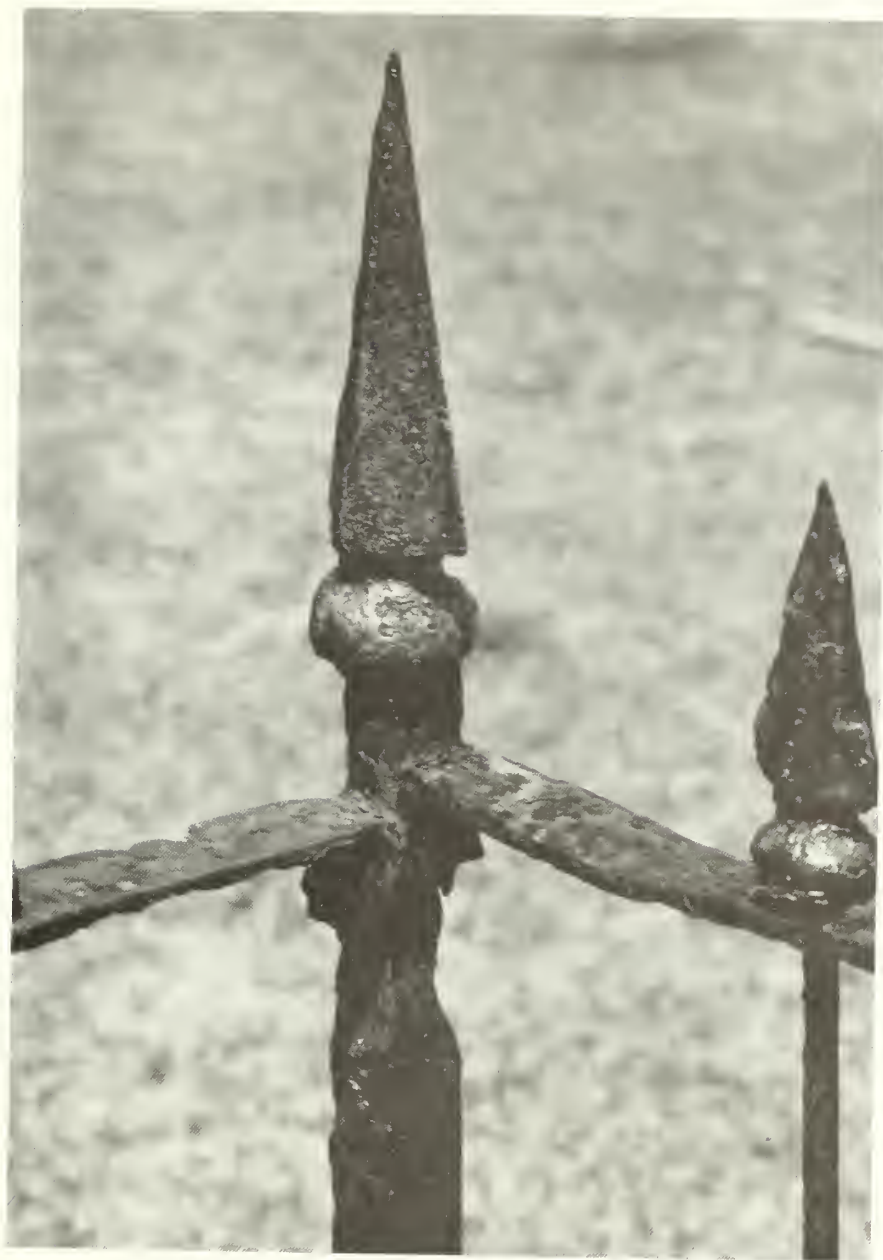
Illustration A113.

Corner post of railing, Fr. Damien's grave. 6/84. R.L.C.

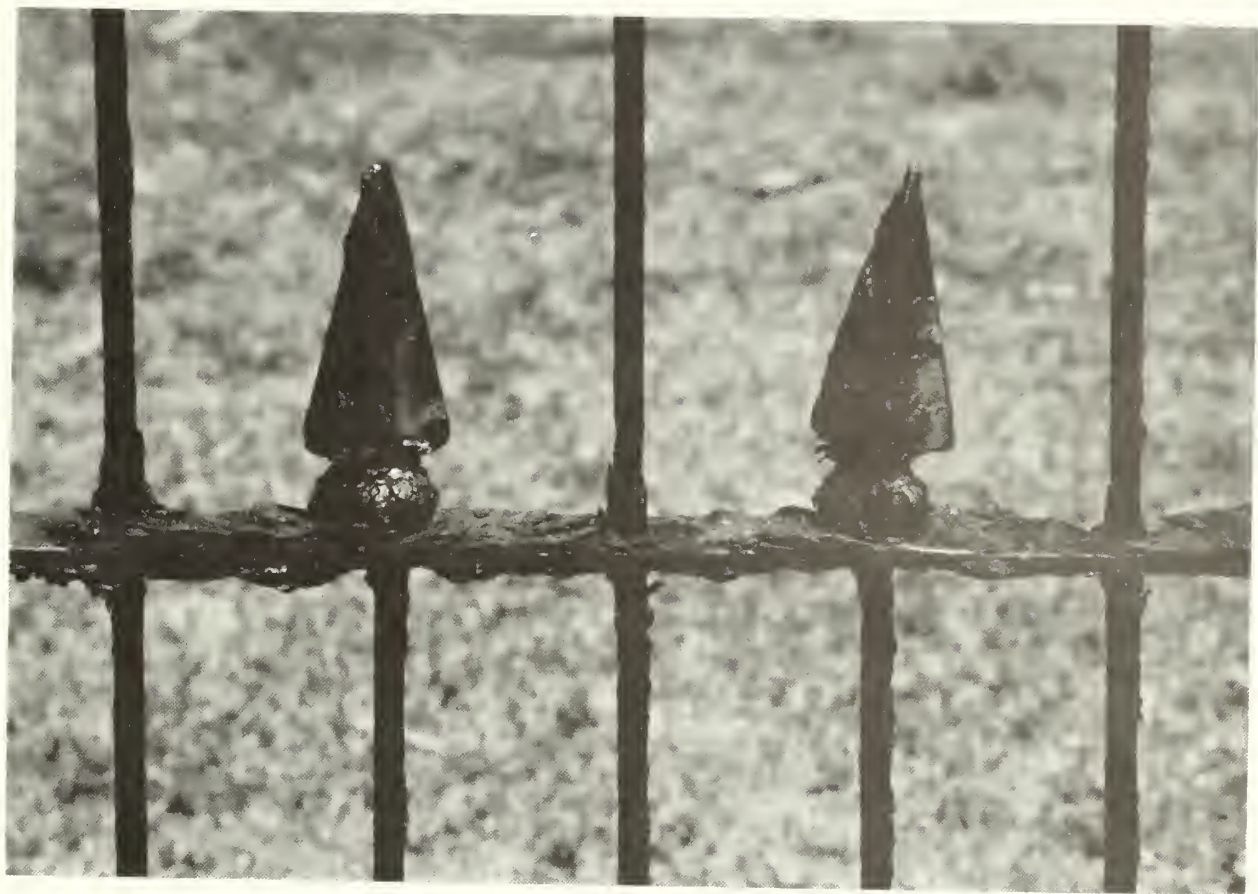
Illustration A114.

Detail at center rail, Fr. Damien's grave. 6/84. R.L.C.

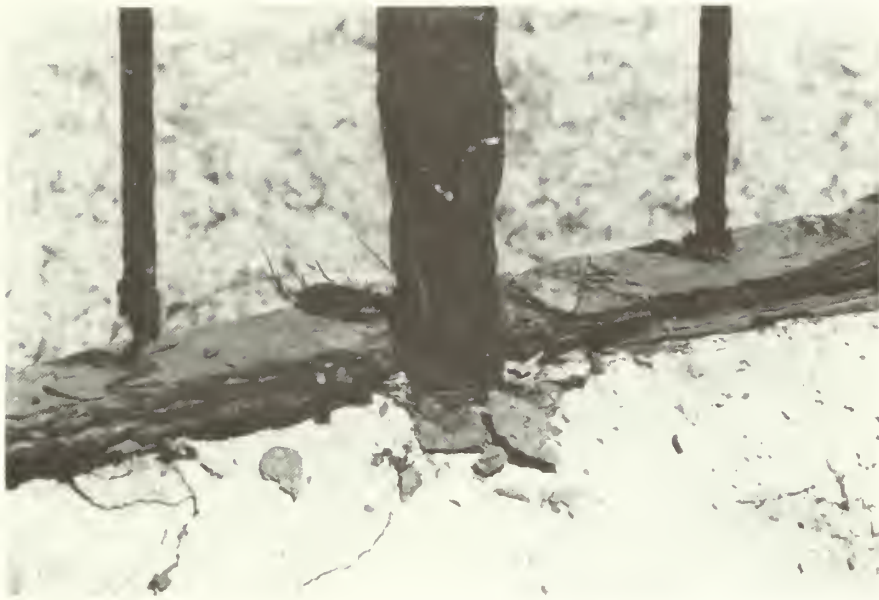
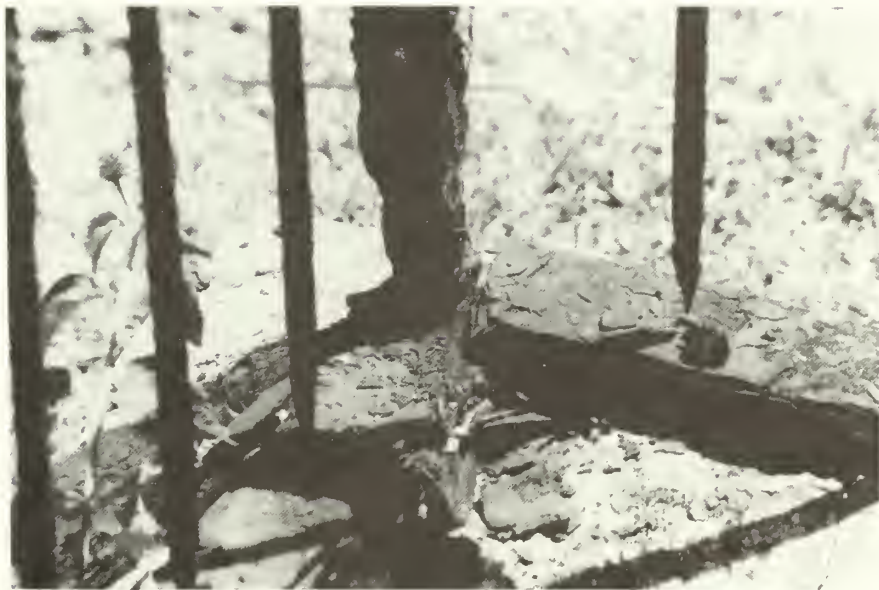
Illustrations A117 and A118.

Details of intermediate and corner post at bottom rail, Fr. Damien's grave. 6/84. R.L.C.

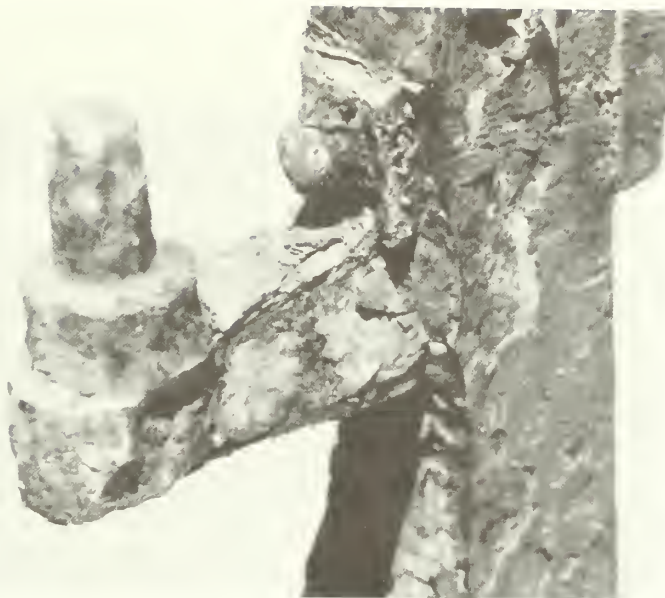
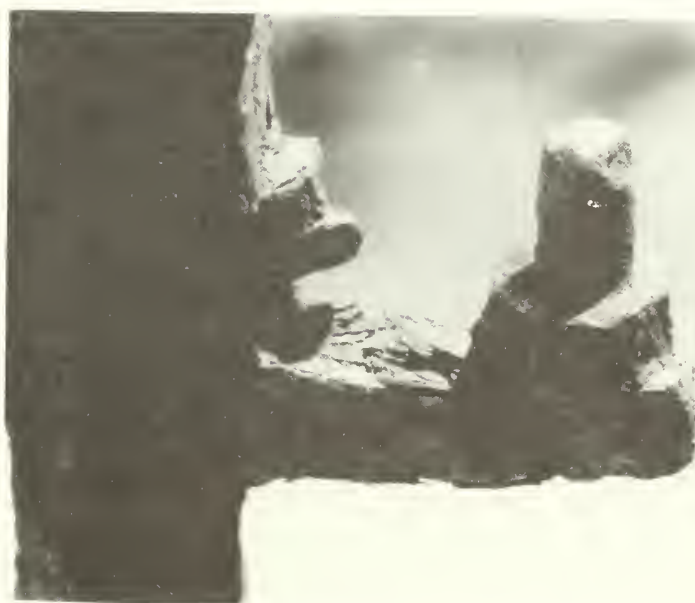
Illustrations A119 and A120.

Gate pintle details, railing of Fr. Damien's grave. 6/84. R.L.C.

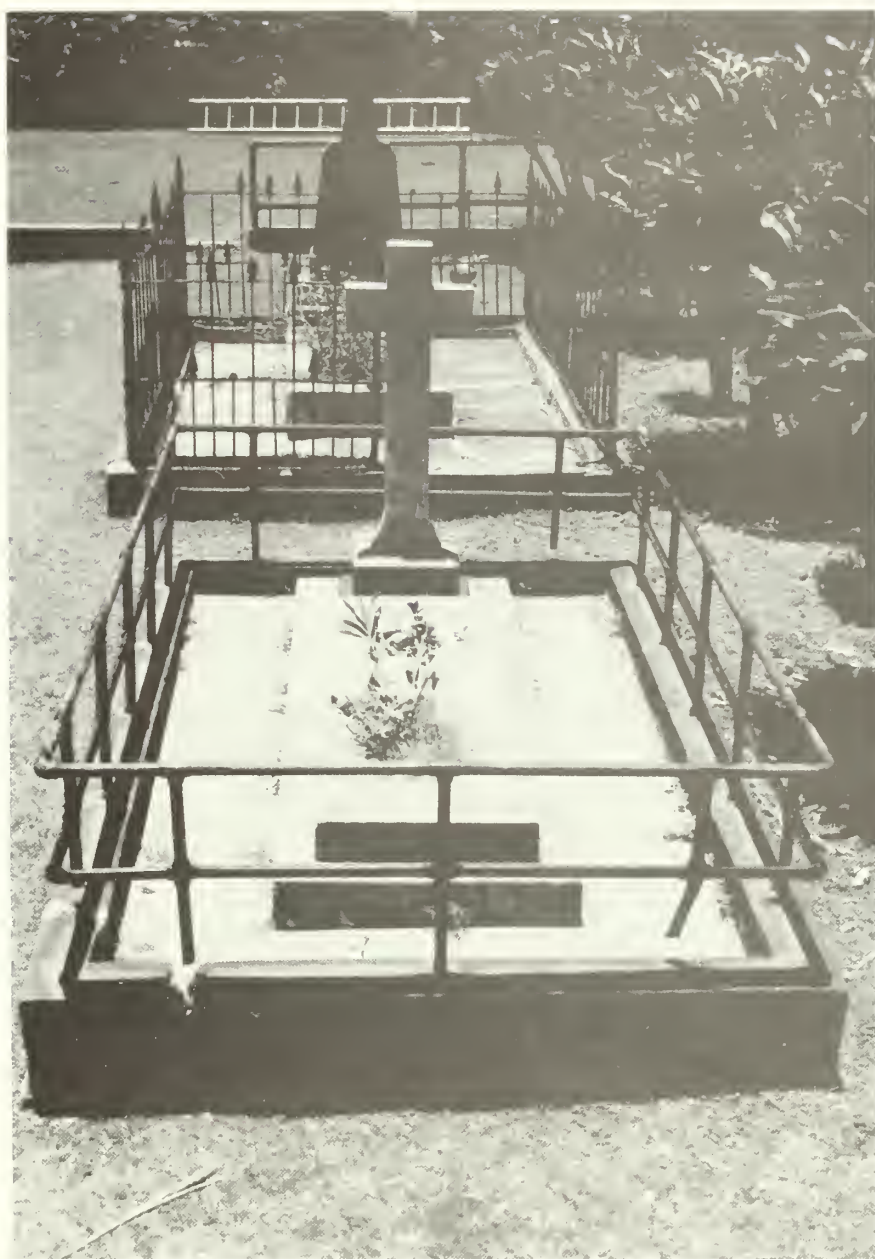
Illustration A121.

Grave of Rev. F. Emmeran Schulte, July 29, 1848 - August 14, 1912,
(No. 2 on Site Plan drawing). 8/84. P.C.C.

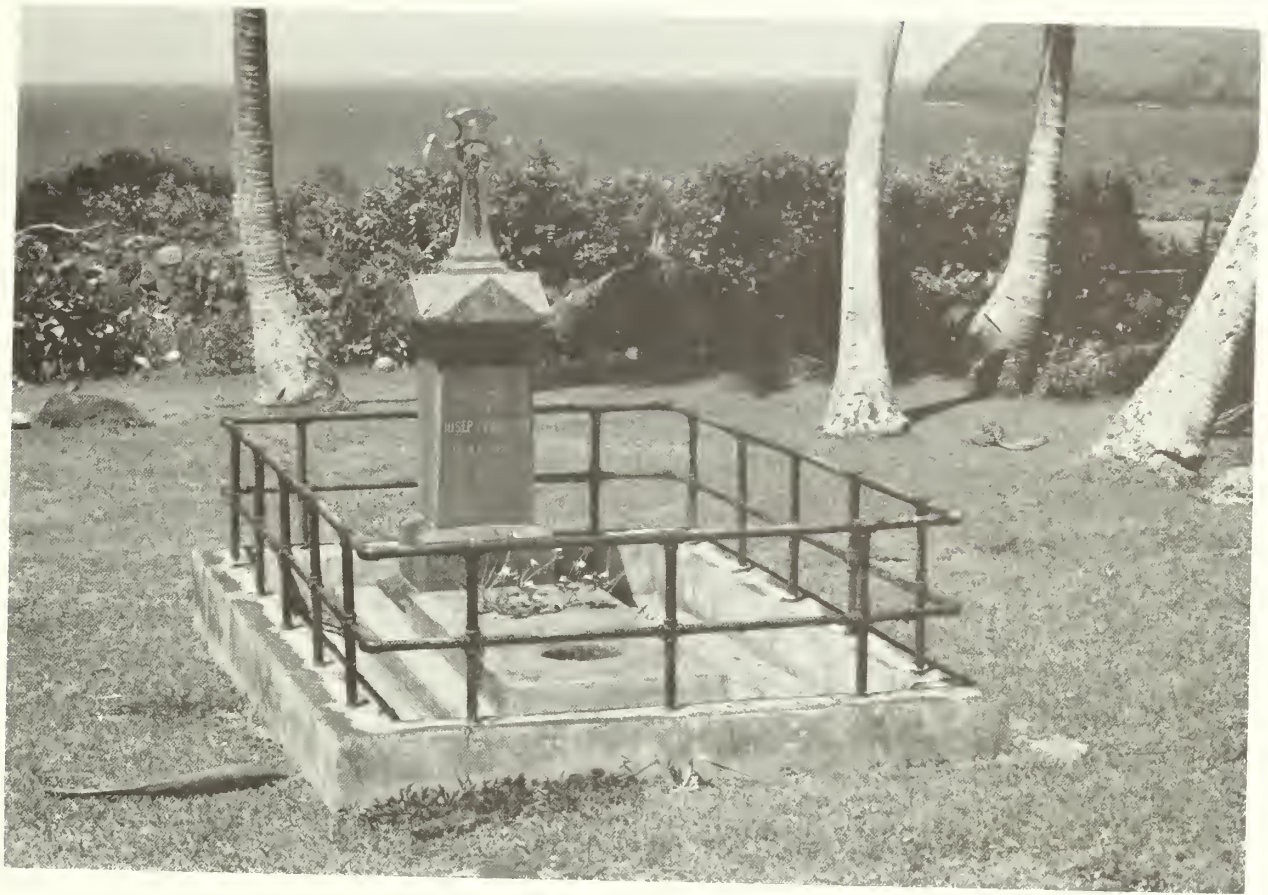
Illustration A122.

Grave of Joseph I. Dutton, 1843-1931 (No. 3 on Site Plan drawing).
6/84. R.L.C.

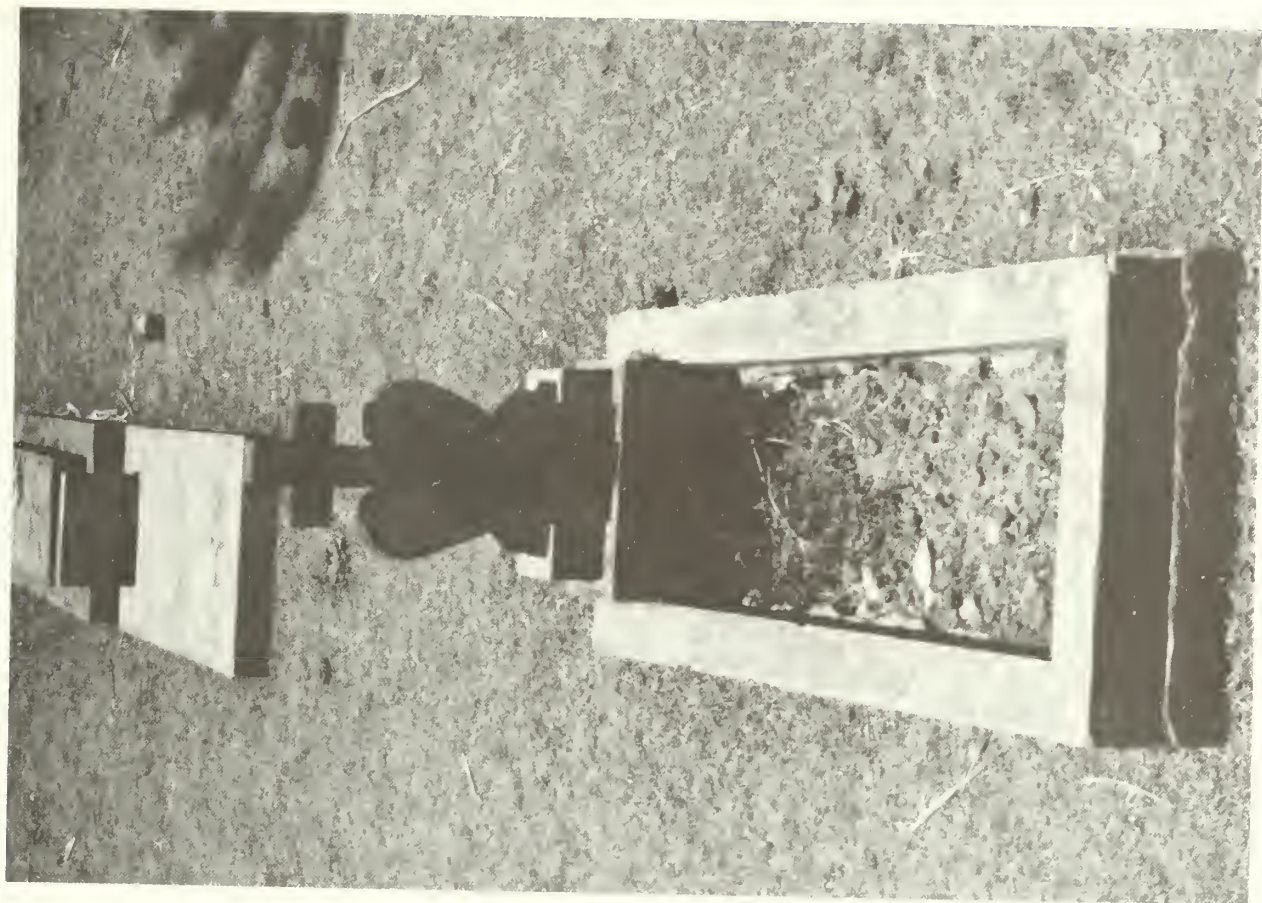
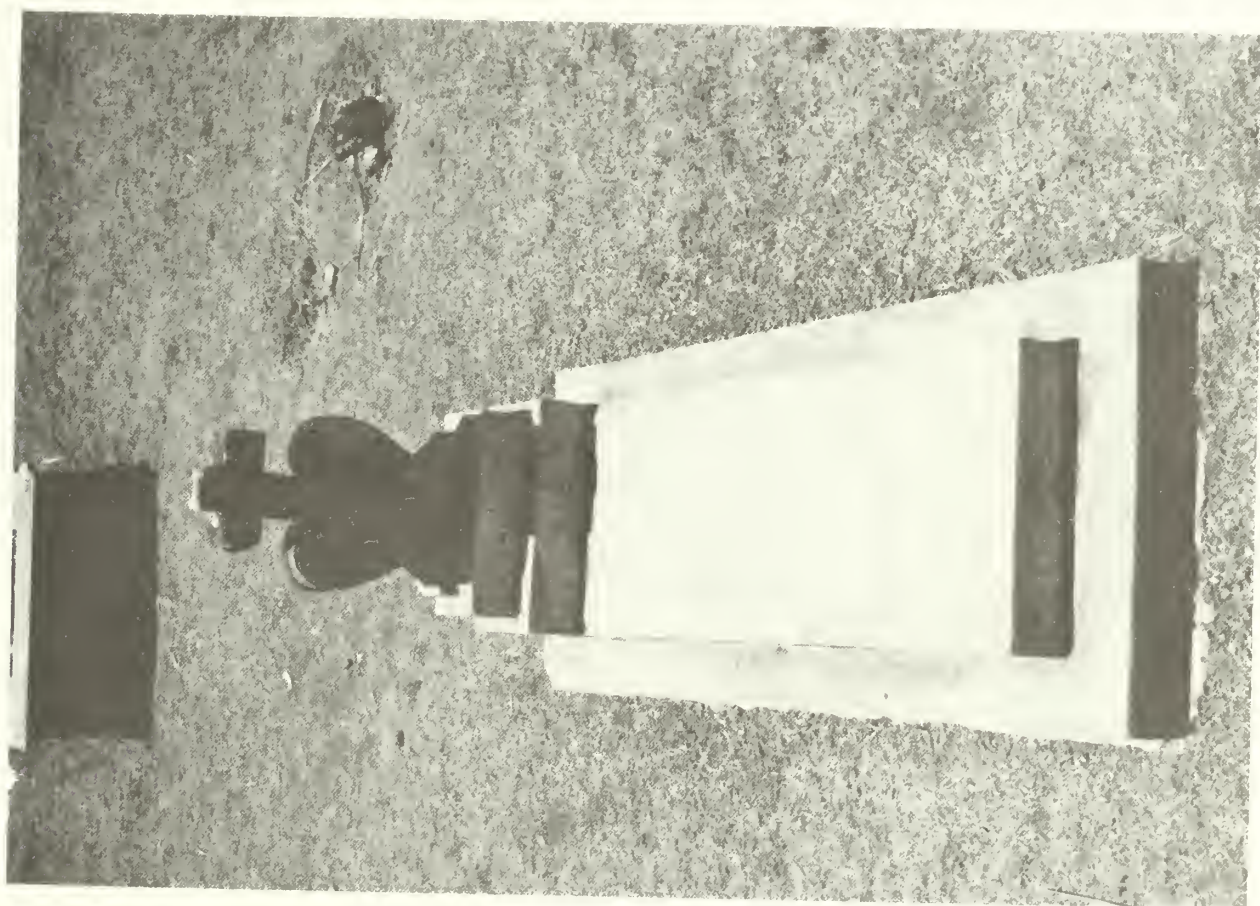
Illustration A125.

Grave of Geo. Kualaku, died Sept. 18, 1927 (No. 5 on Site Plan drawing). 8/84. P.C.C.

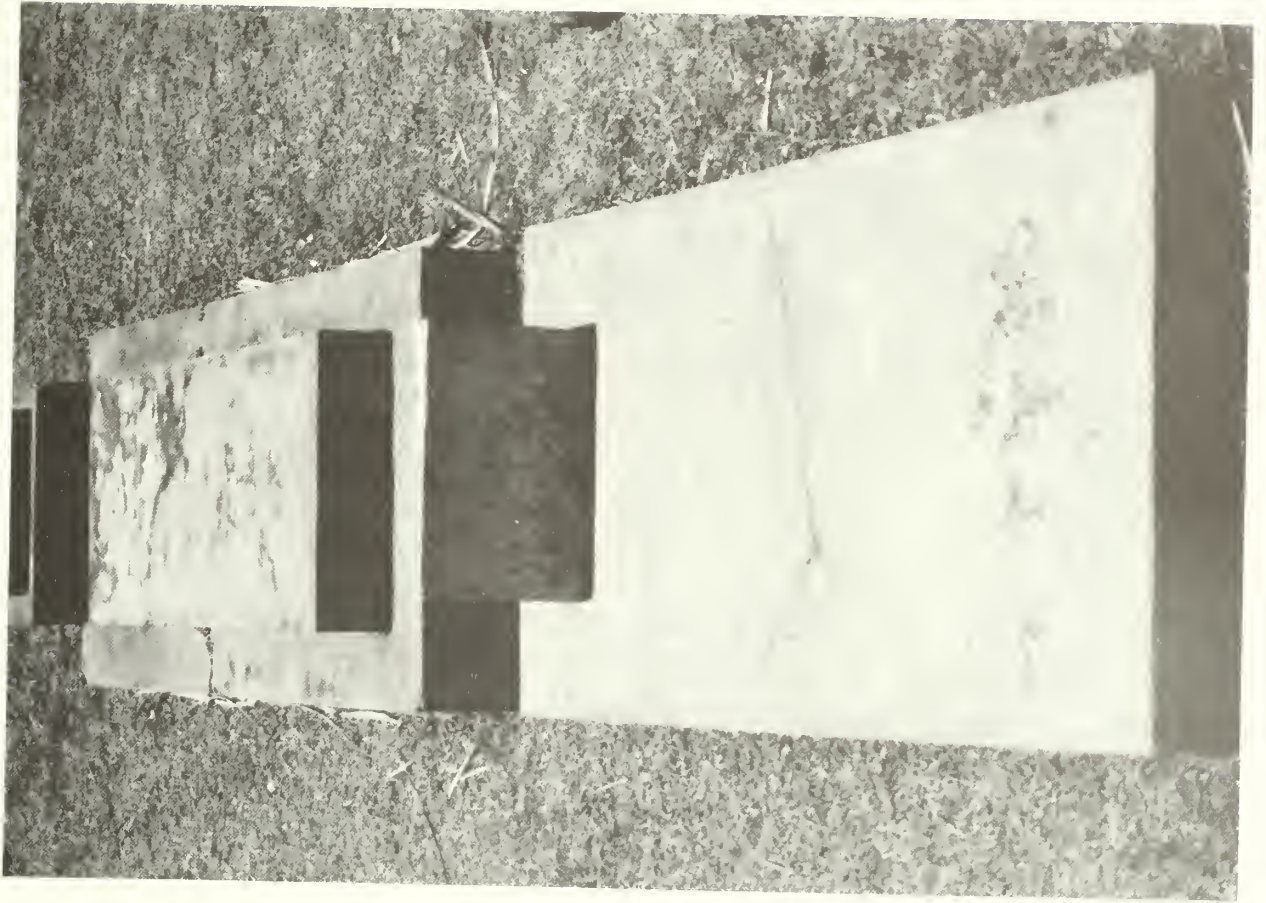
Illustration A126.

Grave of A. Kulani, died Apr. 3, 1927 (No. 6 on Site Plan drawing). 8/84. P.C.C.

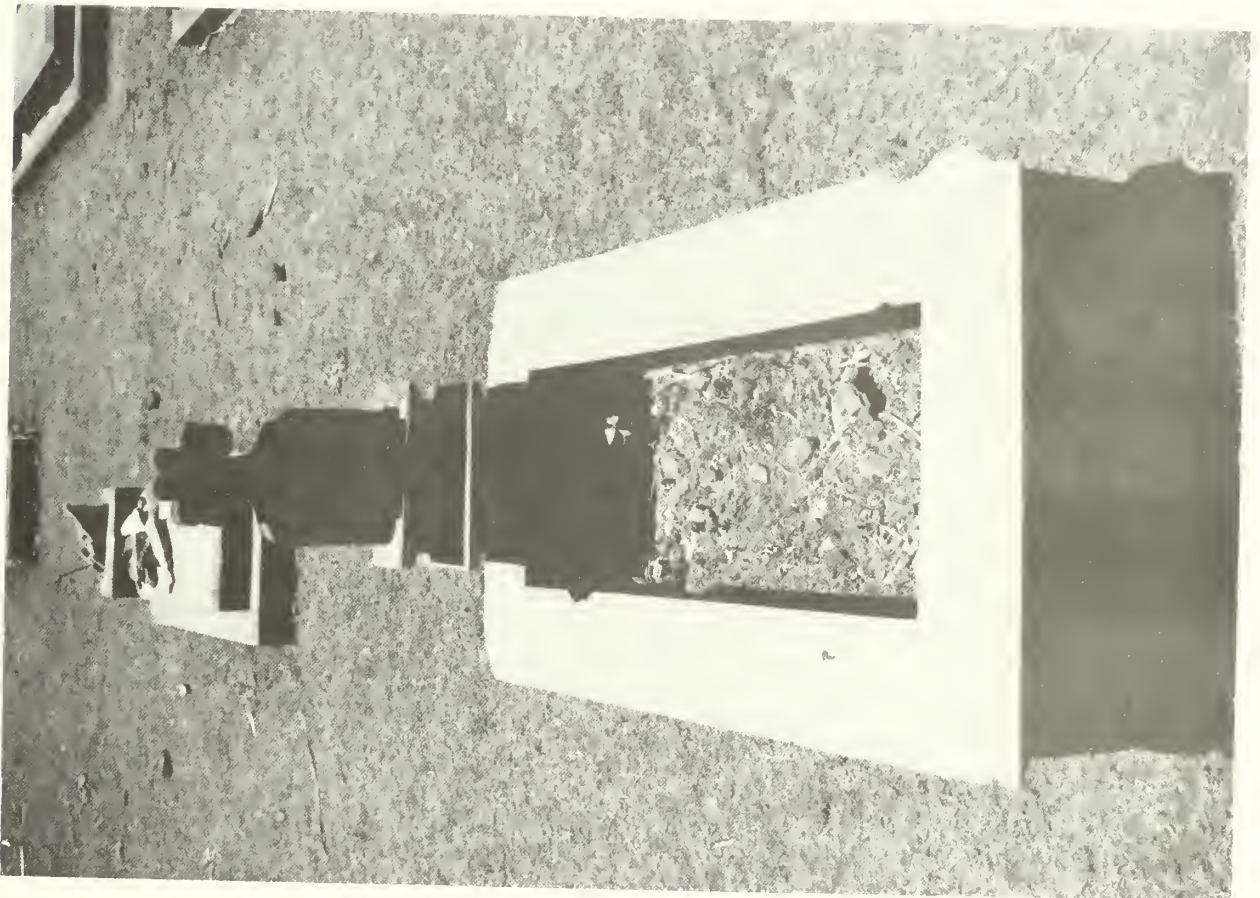
Illustration A127.

Grave of Geo. N. Kaeha, born July 11, 1884, died Nov. 21, 1926 (No. 7 on Site Plan drawing). 8/84. P.C.C.

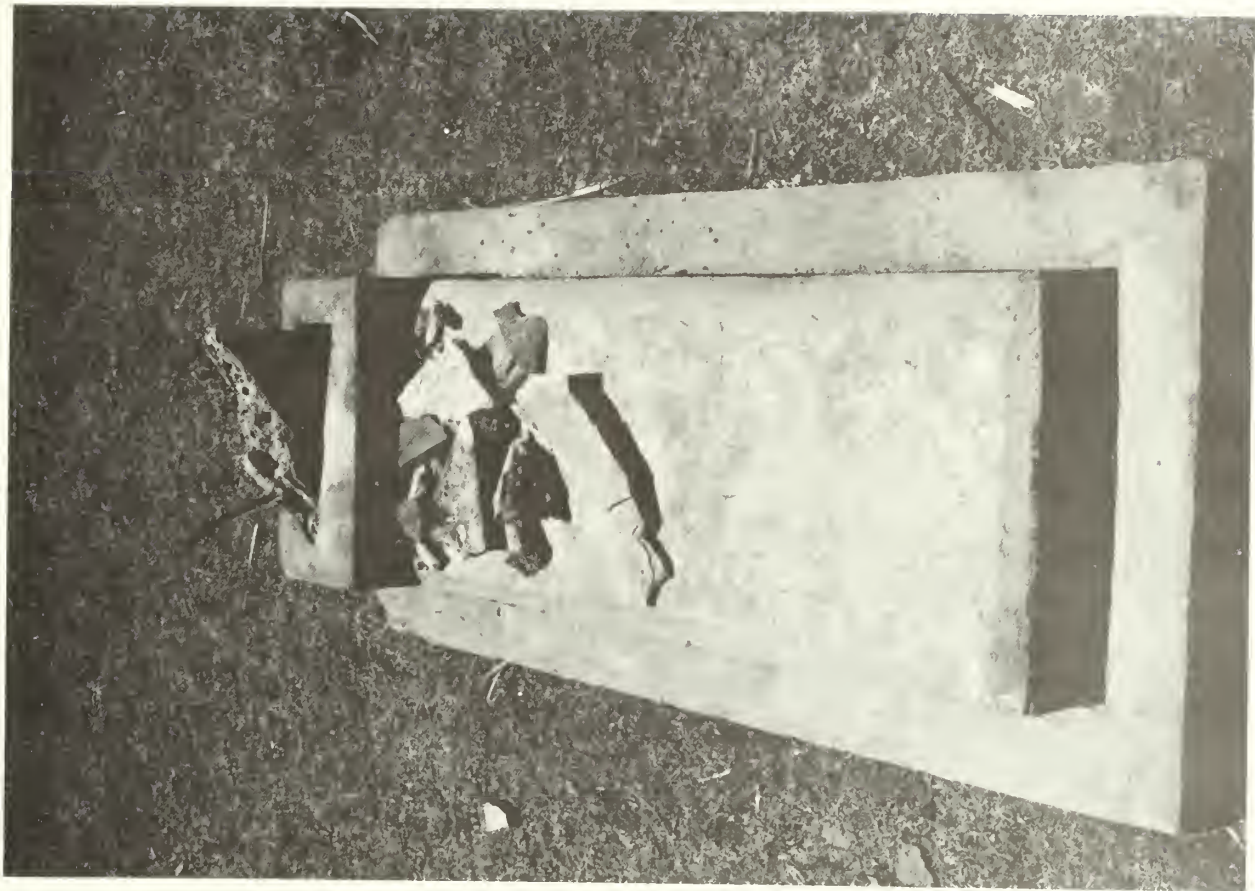
Illustration A128.

Grave of Emmeran Pulakiko, died Jan.
11, 1925 (No. 8 on Site Plan drawing).
8/84. P.C.C.

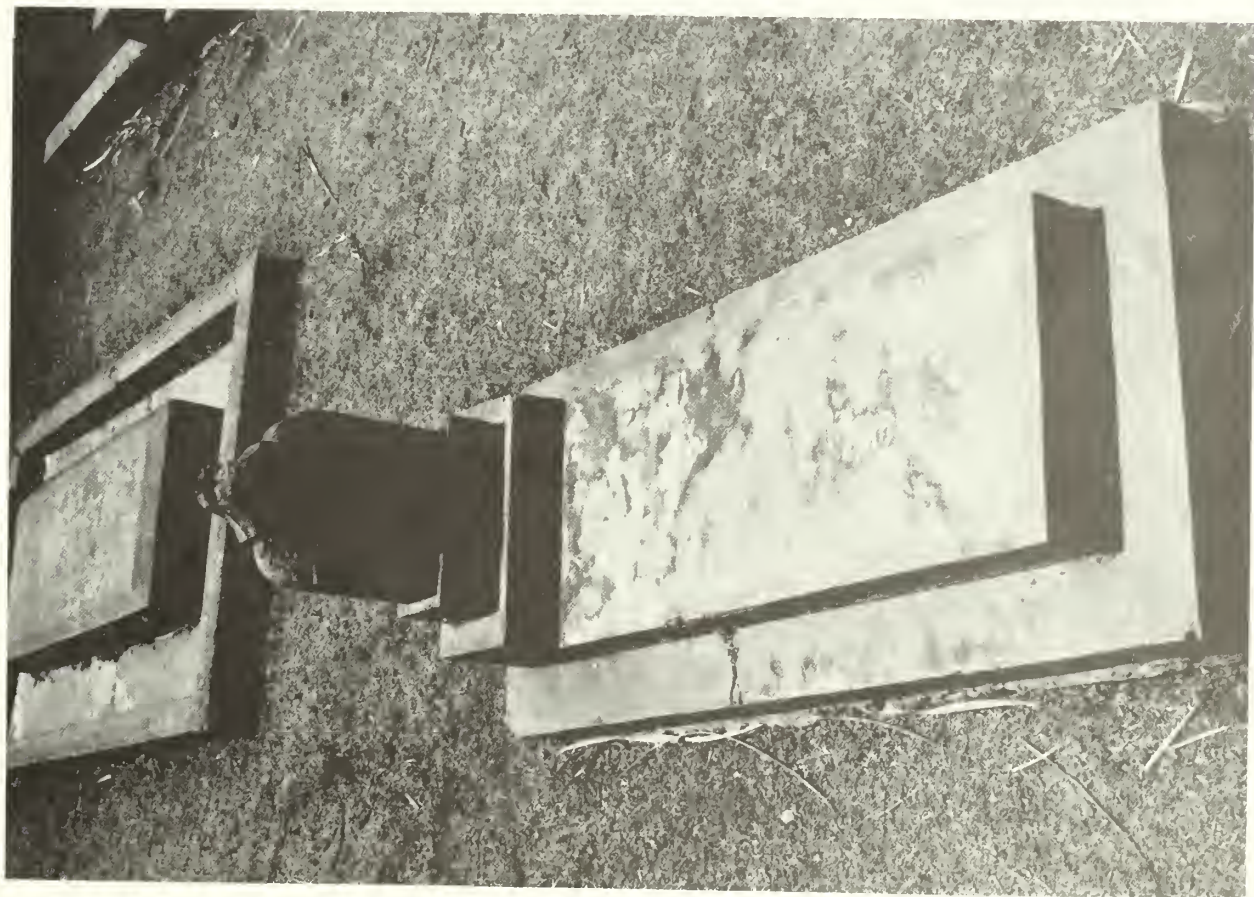
Illustration A129.

Grave of W. (K?)uhia, died May 27, 1924
(No. 9 on Site Plan drawing). 8/84.

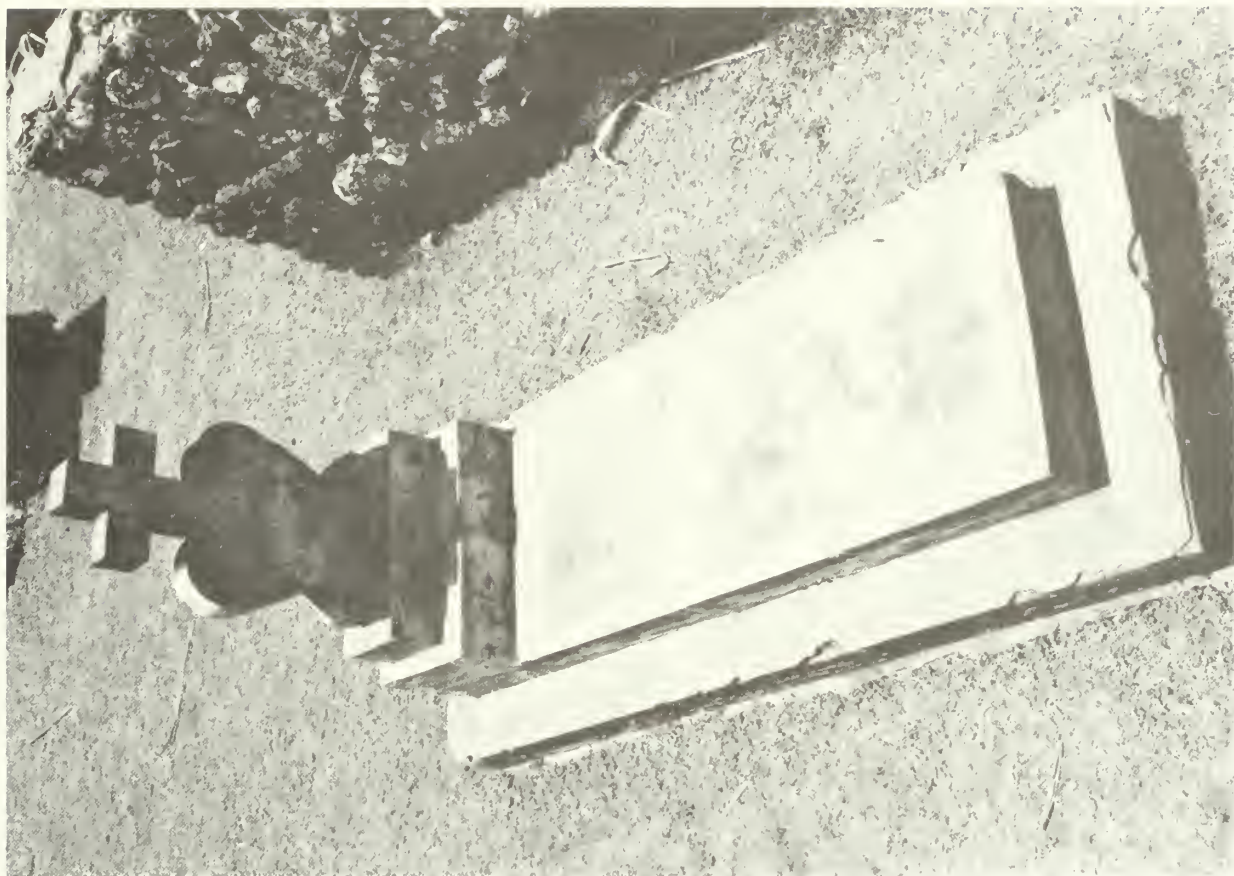
Illustration A130.

Grave of B. Palikapu, died Oct. 23,
1919 (No. 10 on Site Plan drawing).
8/84. P.C.C.
